CASE STUDY

Rotoshear®
William Bolthouse Farms, Inc.

Rotoshear® screens update overloaded treatment plant

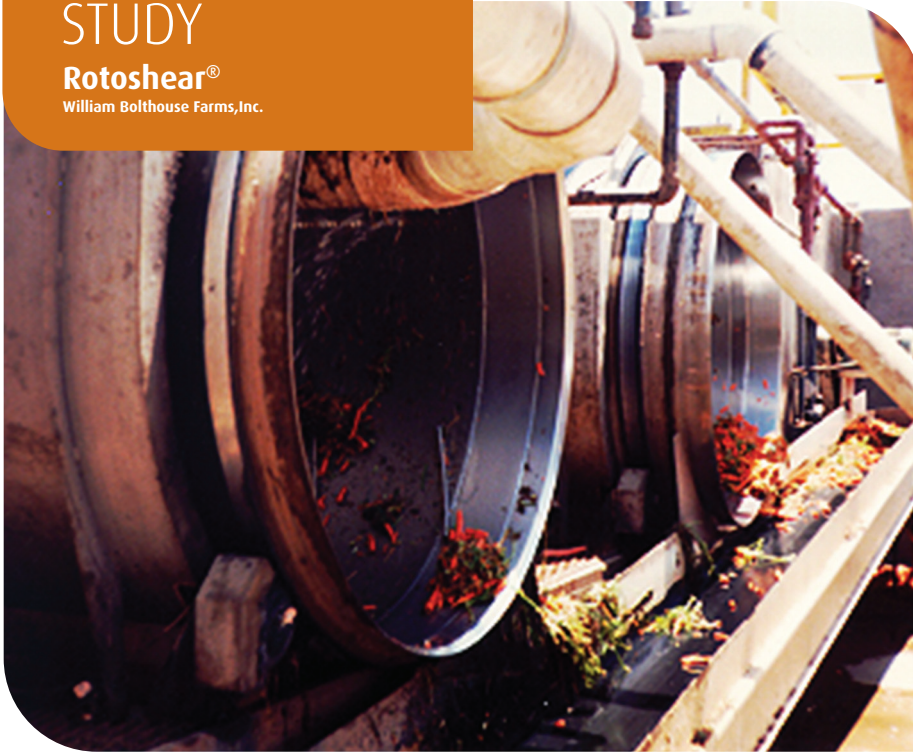
The slotted conveyor was replaced with two Rotoshear® screens, Model HRS60120 with .040" openings. These two large units were squeezed into the allotted area with only minor concrete changes.

Rotoshear® screens have a low headloss requirement, so the gravity flow system was maintained.

The two Rotoshear® units have handled a combined peak flow of 12,000 GPM, a full 2,000 GPM over the anticipated peak flow.

The Rotoshear® unit capably handles these fluctuations and the screen's simple design and minimal number of moving parts has made this low-maintenance, trouble-free equipment. ■
